MULLER MIXER FIRE
"LESSONS LEARNED"

MORTON THIOKOL, INC.

Longhorn Division

↙
The purpose of this paper is to share some of the actions taken by Morton Thiokol, Inc. to enhance safety in pyrotechnic muller mixing operations at Longhorn Army Ammunition Plant. These initiatives resulted from the investigation of a muller mixer fire which occurred on October 30, 1985. It is the safety management philosophy of Morton Thiokol Ordnance Operations that all explosive accidents and significant near miss incidents be thoroughly investigated, by the Engineering and Safety Committee, utilizing a safety systems approach. This committee, which is chaired by the Director of Engineering, B. V. Diercks at the Longhorn Division, was charged with identifying the causative deficiencies and ancillary procedural, equipment design and human engineering changes required to enhance the overall system. To assist Mr. Diercks in this investigation, the following personnel were key contributors in the safety initiatives developed from the analysis of this incident:

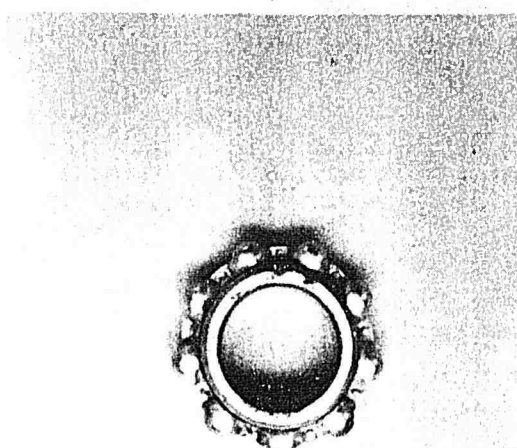
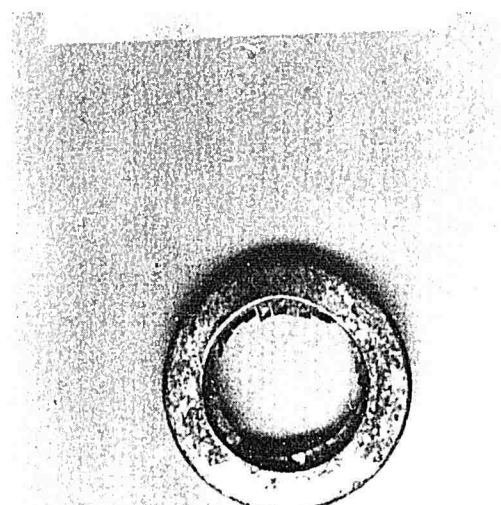
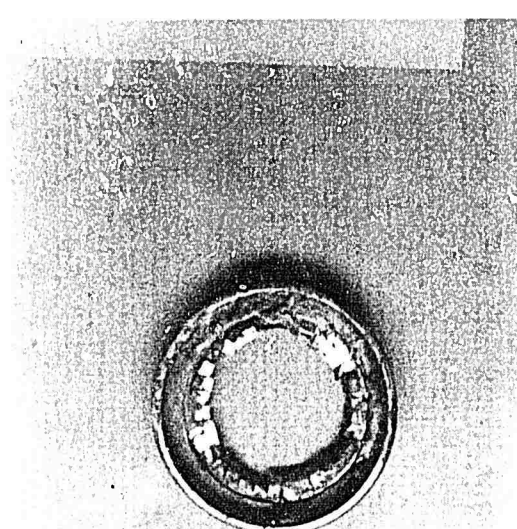
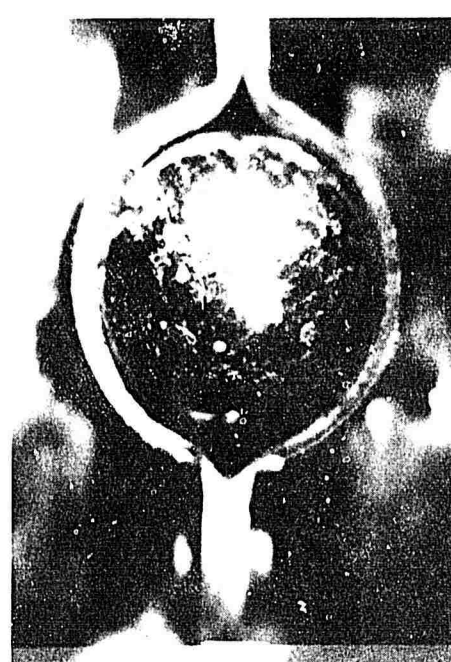
Figure 5

The most probable cause was identified during detailed disassembly of the muller wheels which found a damaged Garlock Klosure Lip Seal. Under microscopic examination it was apparent that the metal spring fingers in the lip seal had made metal to metal contact with the axle plus there was indication of fire in the area. Small amounts of explosive contamination were also found past the lip seals in bearings of both the muller wheel and center support post. To correct this deficiency the muller wheel assembly (Figures 3 and 4) has been redesigned with a redundant Ethylene Propylene "O" ring seal plus potting the void in lip seal with solvent resistant Epon 828 and Versamid 125 filler. The lip seal filler prevents explosive product entrapment and build up at the edge of the lip seal, protects finger springs, and aids in cleaning of center support post lip seal. The effectiveness of this lip seal configuration was tested in inert and live prove out mixes which established a twenty (20) shift replacement schedule of all lip seals and bearings. This preventive maintenance baseline may be extended as future experience warrants. Eight months of continuous operations has seen no migration of product past lip seals. (See Figure 5)

GARLOCK KLOUSURE LIP SEAL
